Advanced Test & Balance Report Review

National Comfort Institute, Inc.

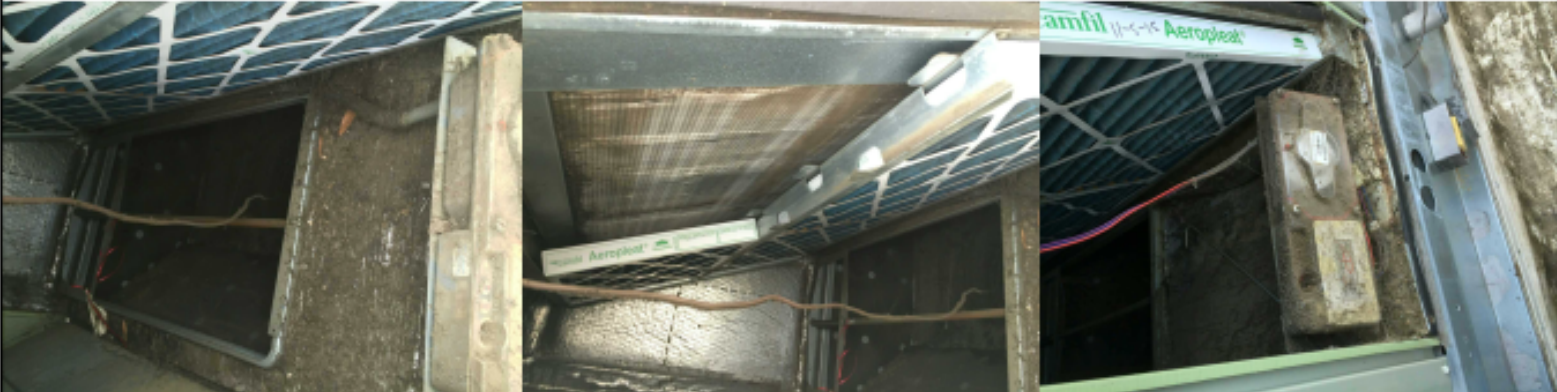
After being referenced in the General Remarks / Executive Summary, Outstanding Deficiencies should appear in an itemized manner, preferably with pictures. The example below uses Airnab reporting software.

Deficiency ID:	0010	Status:	Open	Deficiency Priority:	
Equipment:	RTU-03 Storage				Created Date: 27-Jan-16 Due Date:
Issue Description:					
Unit has excess particulates building up on filters and coils resulting in less air flow and increased strain on overall system.					
Issue Type:	Incomplete	Job Tag:	Repair Estimate:		
Role Assignment:	Company Project Manager	Cross Ref#:	Replacement Cost:		
User Assignment:					
Comments / Signature:					
Issue Photos:

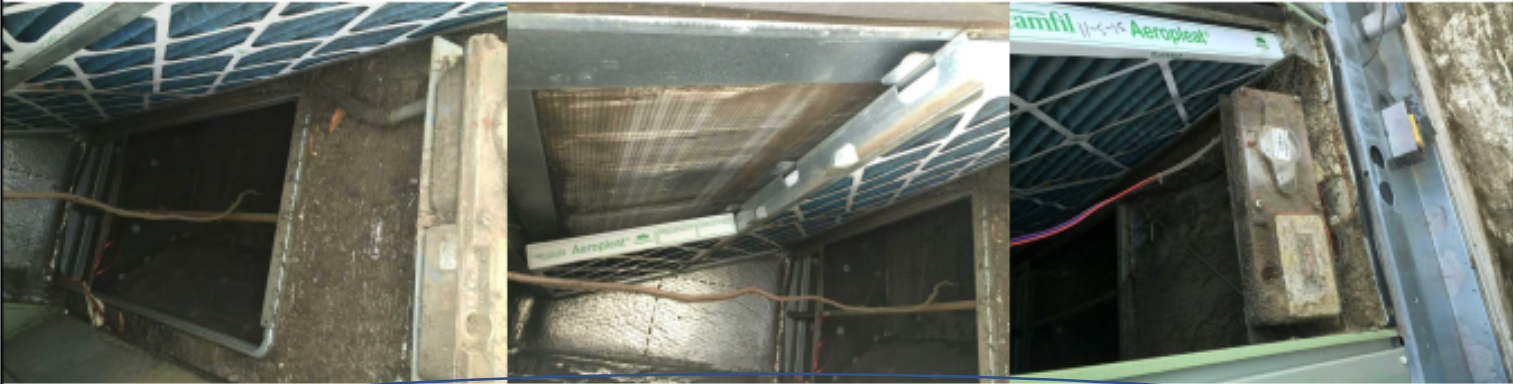
Deficiency ID:	0010	Status:	Open	Deficiency Priority:	
Equipment:	RTU-03 Storage				Created Date: 27-Jan-16 Due Date:
Issue Description:					
Unit has excess particulates building up on filters and coils resulting in less air flow and increased strain on overall system.					
Issue Type:	Incomplete	Job Tag:	Repair Estimate:		
Role Assignment:	Company Project Manager	Cross Ref#:	Replacement Cost:		
User Assignment:					
Comments / Signature:					
Issue Photos:

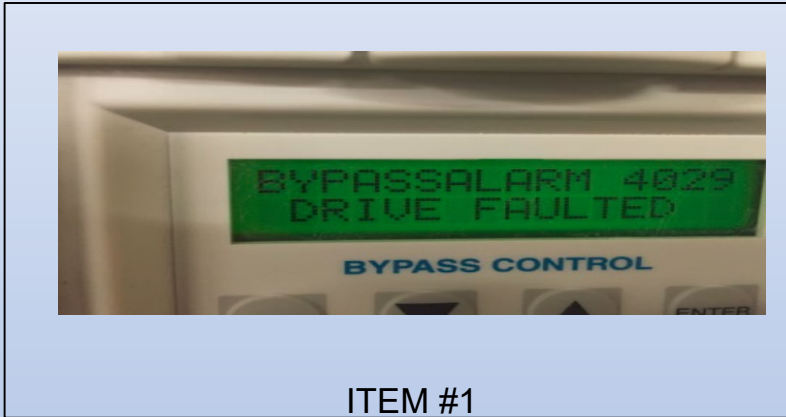
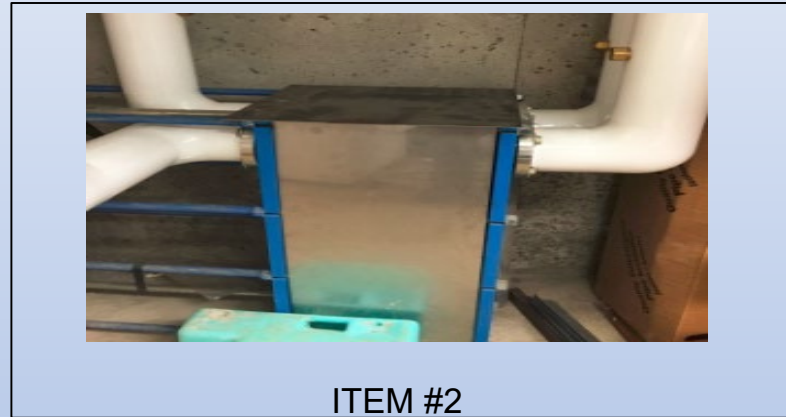
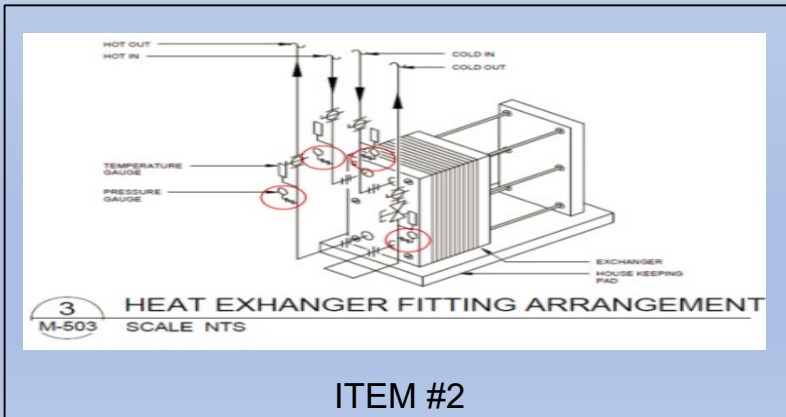
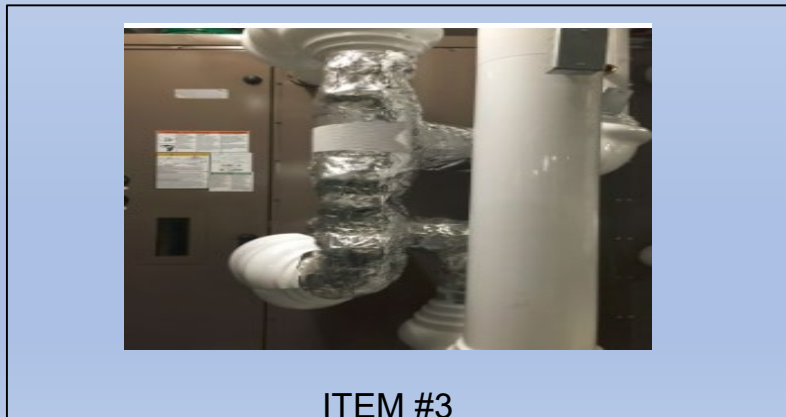
TAB DEFICIENCY REPORT

Project: Silent Hill Assisted Living		Project Number: 1409	
		Location: Centralia, PA		Owner: Umbrella Corporation	
		Mechanical Contractor: Weyland A / C		Date: 10.21.15	
		Certified TAB Firm: Brawndo TAB		Certified TAB Technician: M. McFly	
TAB Deficiency Report					
ITEM No.	SYSTEM	DATE	ISSUE	STATUS	CONTRACTOR REMARKS
001	Pump-1	10.21.15	Pump will not run in hand or automatic. Error message at VFD reads "Bypass Alarm 4029 Drive Faulted."	Open	
002	HX-1	10.21.15	There are no test ports installed at heat exchanger. Test ports required by detail 3 on page M-503 of mechanical draws. Can not test at this time.	Open	
003	AHU-2	10.21.15	Insulation for chilled water piping is incomplete & has been wrapped in silver tape. Does not impact TAB, but will cause condensation issues.	Open	
004

The following pictures / details correspond with the line items from TAB Deficiency Report Dated

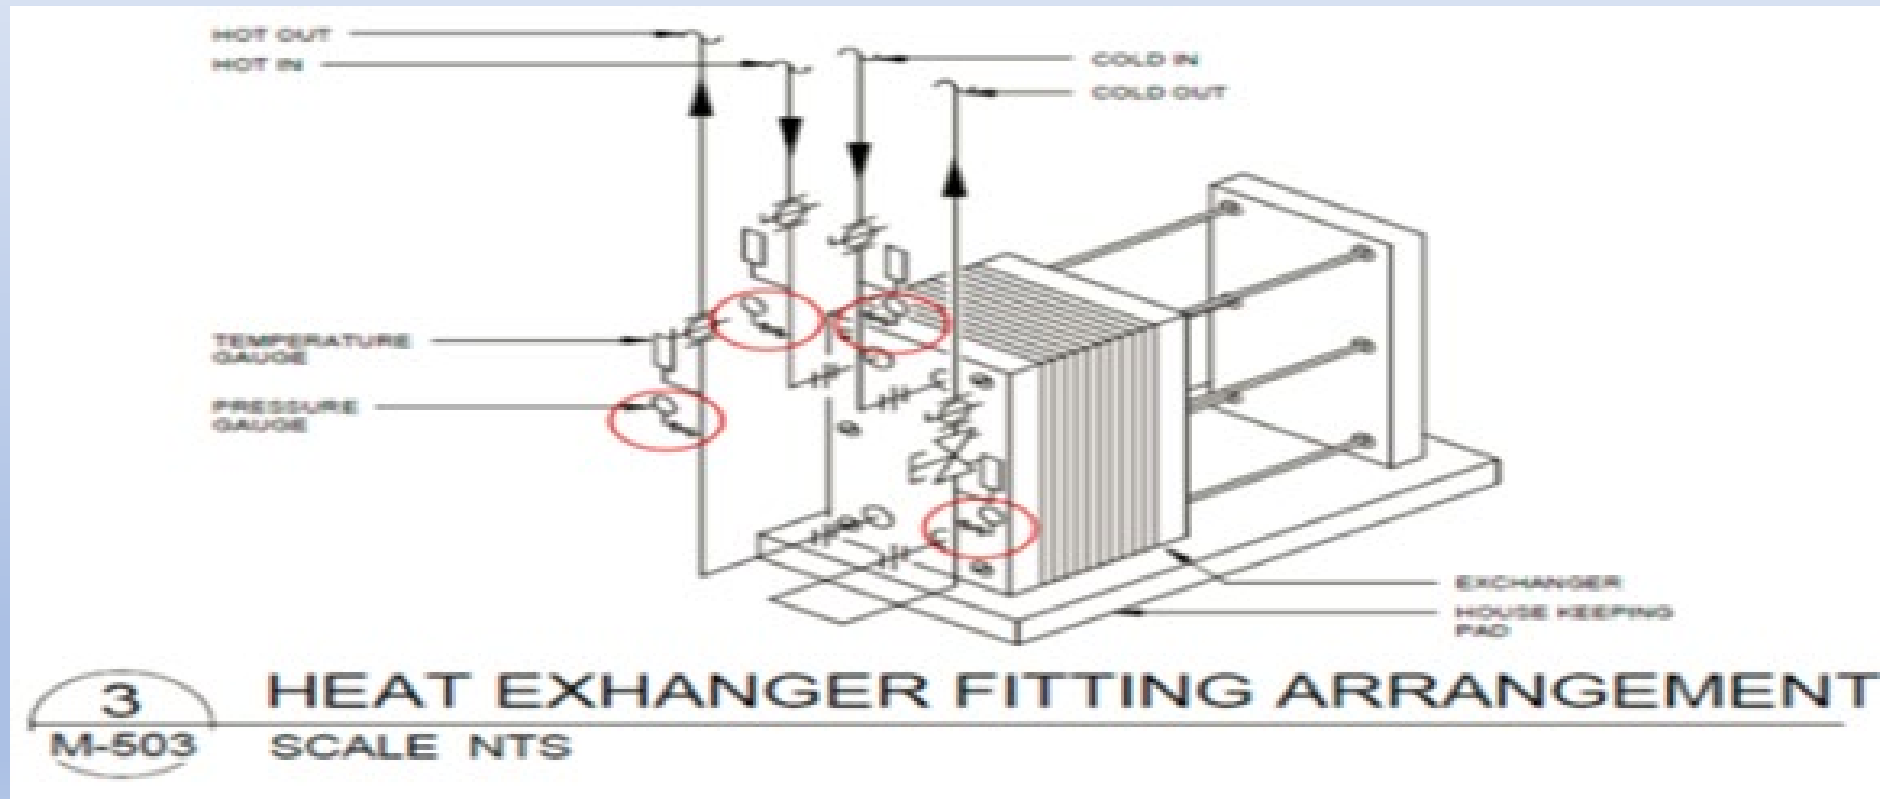
Mechanical Details are useful references that assist the end user in understanding the deficiency and clarifying what actions the contractors need to take.

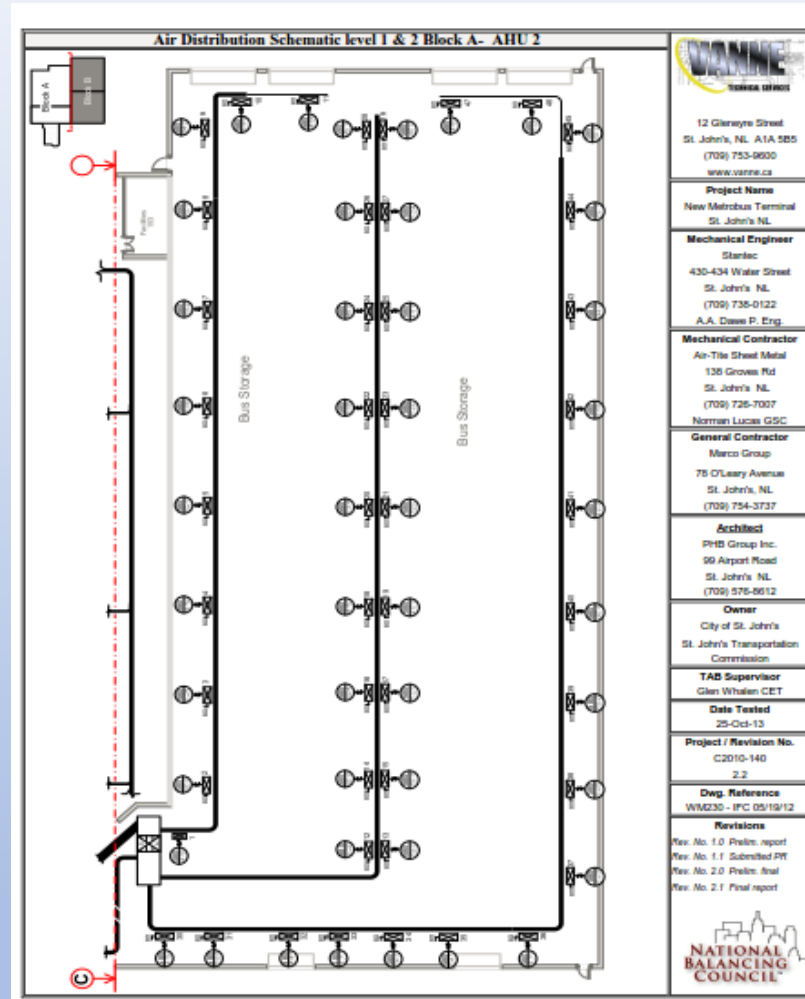
Sample of Mechanical Drawings generated by the TAB Contractor.

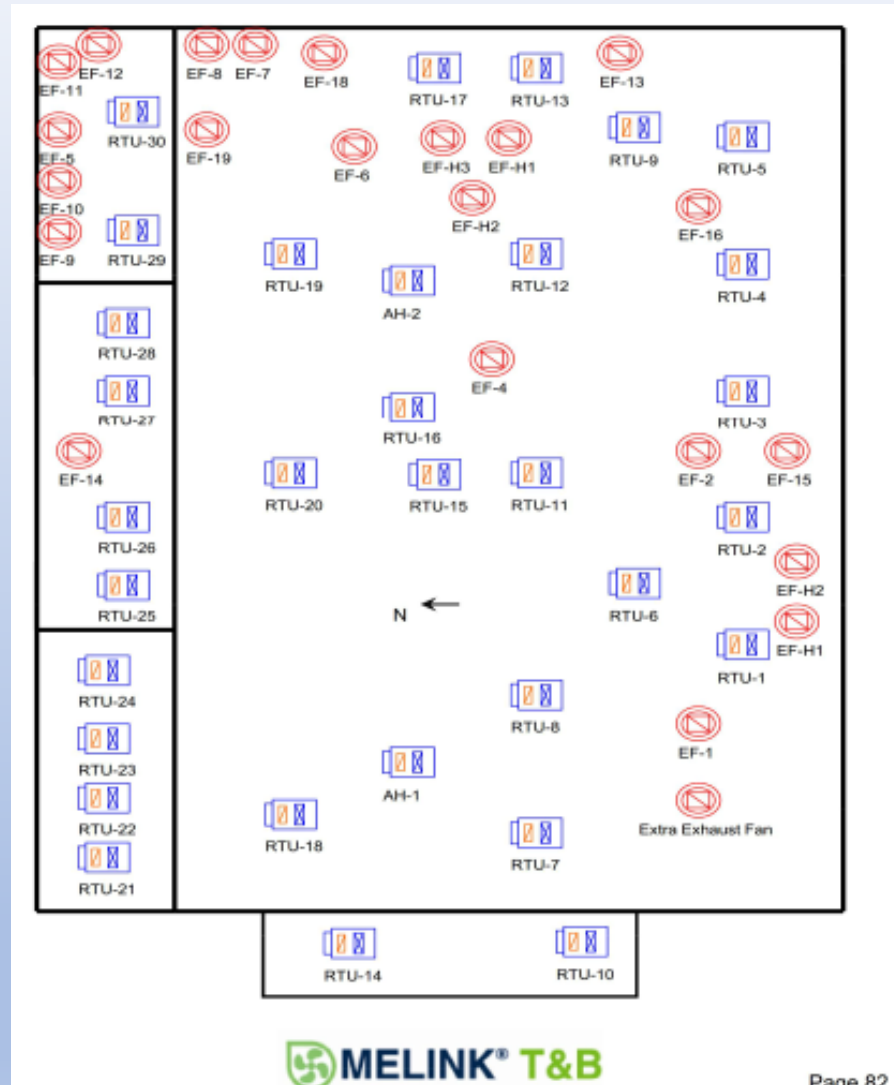
TAB contractor
generated roof plan.

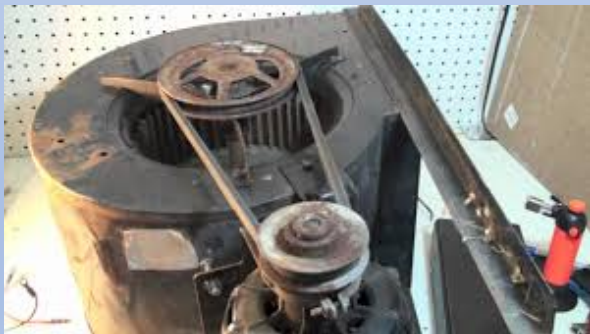
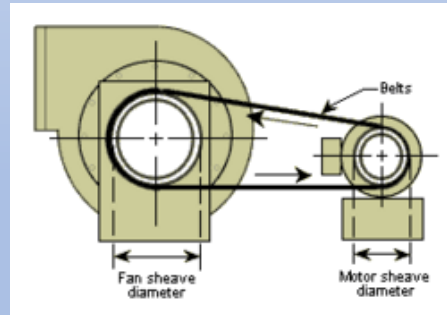
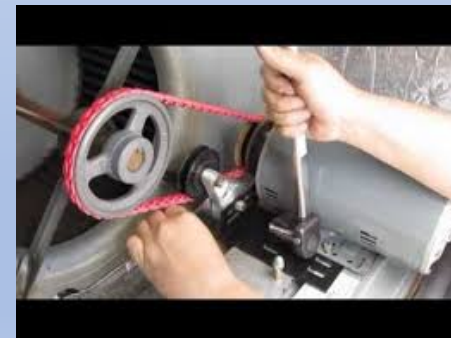
On belt-driven fans, the fan pulley/sheave is typically larger than the motor pulley/sheave. It is not uncommon for these values to be swapped in the final TAB report.

If this is noticed, apply the Max Fan RPM formula against the recorded RPMs and drive package. If it doesn't work, swap the numbers for the pulleys / sheaves and run the formula again.

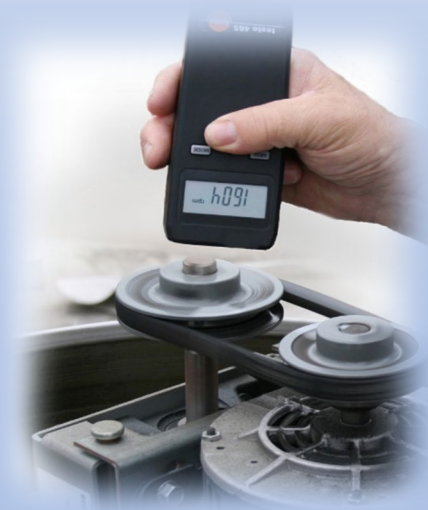
Note: On standard, roof mounted exhaust fans the pulley / sheave sizes are typically closer in size than belt driven RTUs / AHUs etc.

The fan pulley / sheave is still typically larger and the same Max Fan RPM Formula applies.

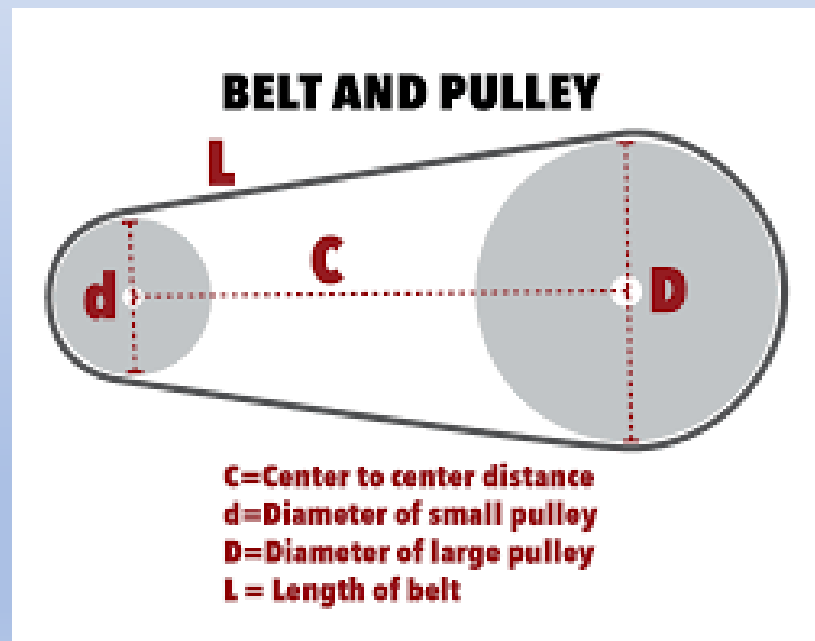
When belt data is missing, confusing or not logical, apply the belt sizing formula to confirm...

Apply the Belt Sizing Formula to see if the data makes sense...

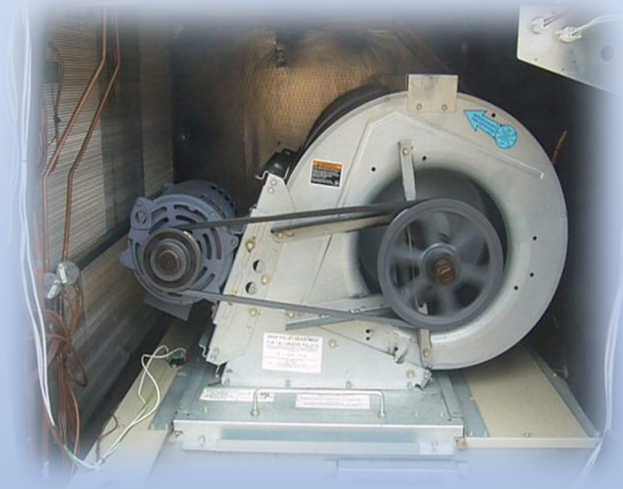
Belt Length Formula

$$\text{Belt Length} = 2C + [1.57 \times (D_1 + D_2)] + 1''$$

C = Distance Between Shafts

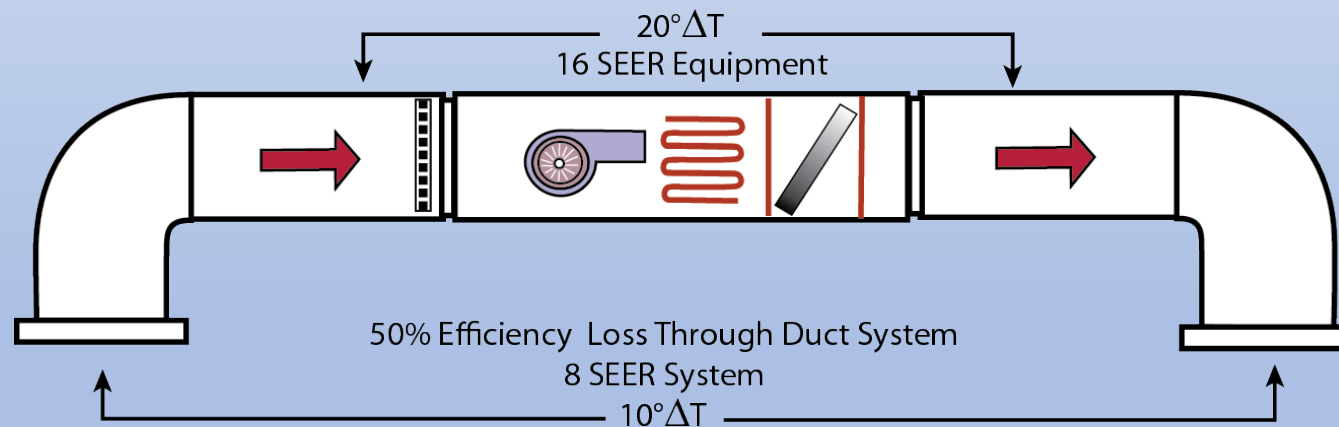
Standard Delta-T on a DX unit is 20°, at 400 cfm per ton of air conditioning, at 12,000 Btus.

If a TAB report states That a 5 ton DX RTU is moving 1,000 cfm, yet the TAB report shows a 20° split, and coils aren't frozen, there is something wrong with the data.

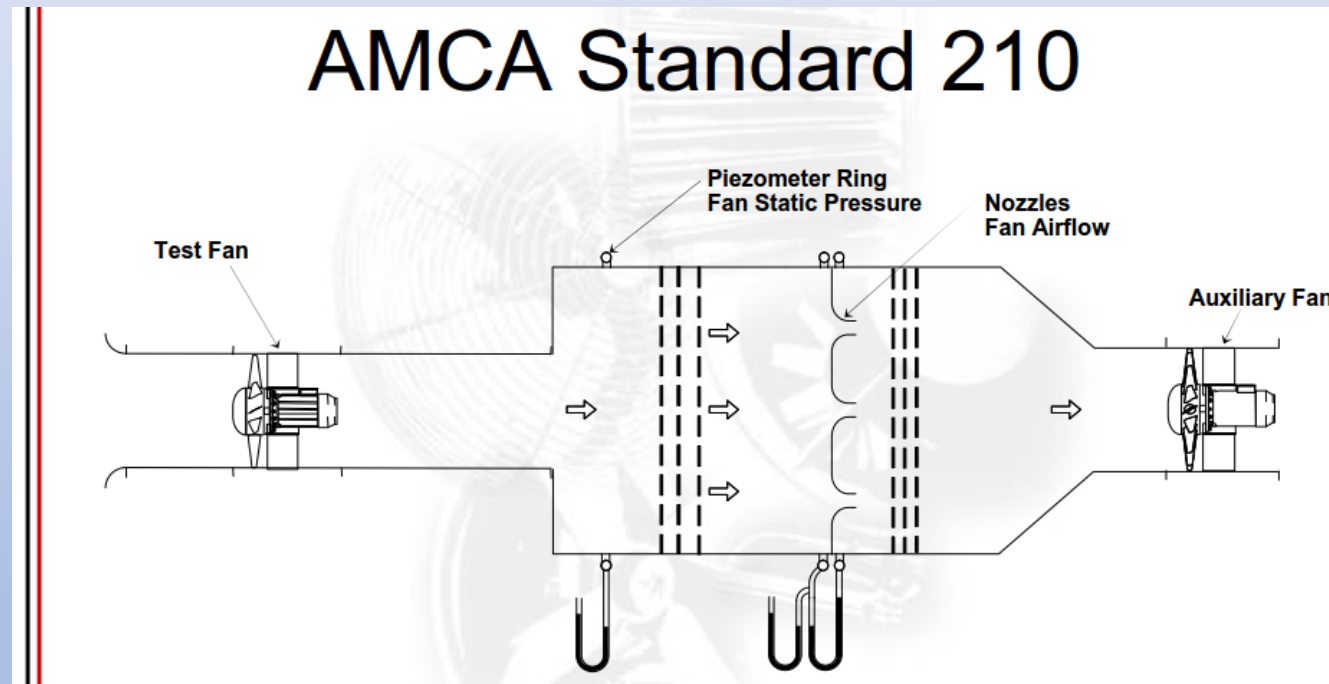
Theory.....

Fan Curves are developed under laboratory conditions, under AMCA Standard 210.

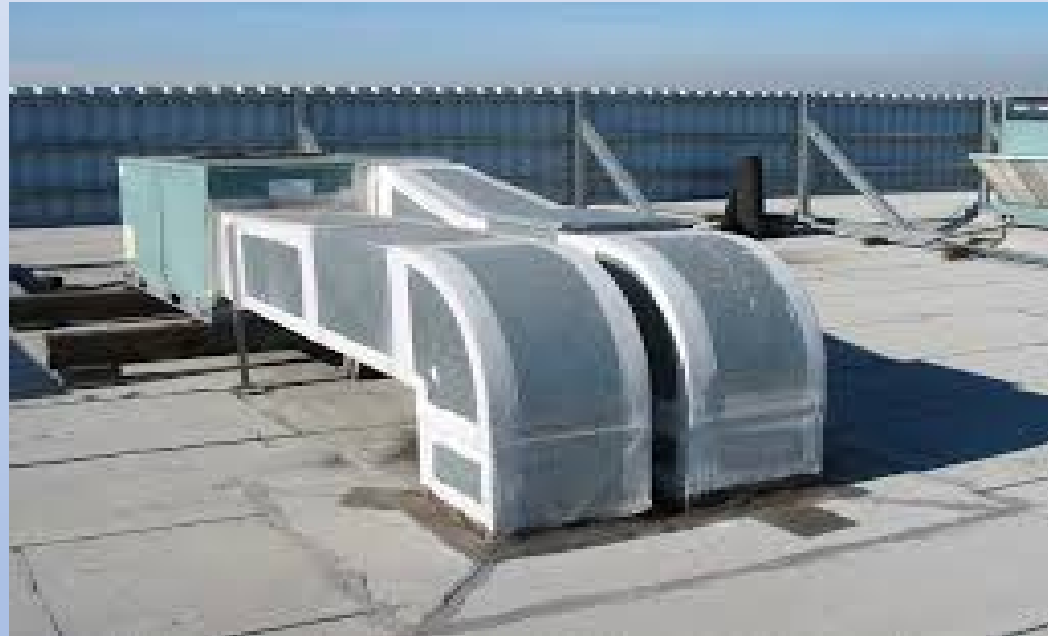
vs. Reality...

- Fan Curves DO NOT take into account System Effect, caused by installation conditions.
- Fan curves are still very practical in regard to TAB report review, as they provide logical parameters.
- Once installed, the fan curves / fan tables NEVER line up exactly, due to field and installation conditions.
- How was BHP determined? Was it read or calculated? Was motor tag Eff and PF used or were plug values used? If so, which one? .8 and .9? .8 and .85? .8 and .7?

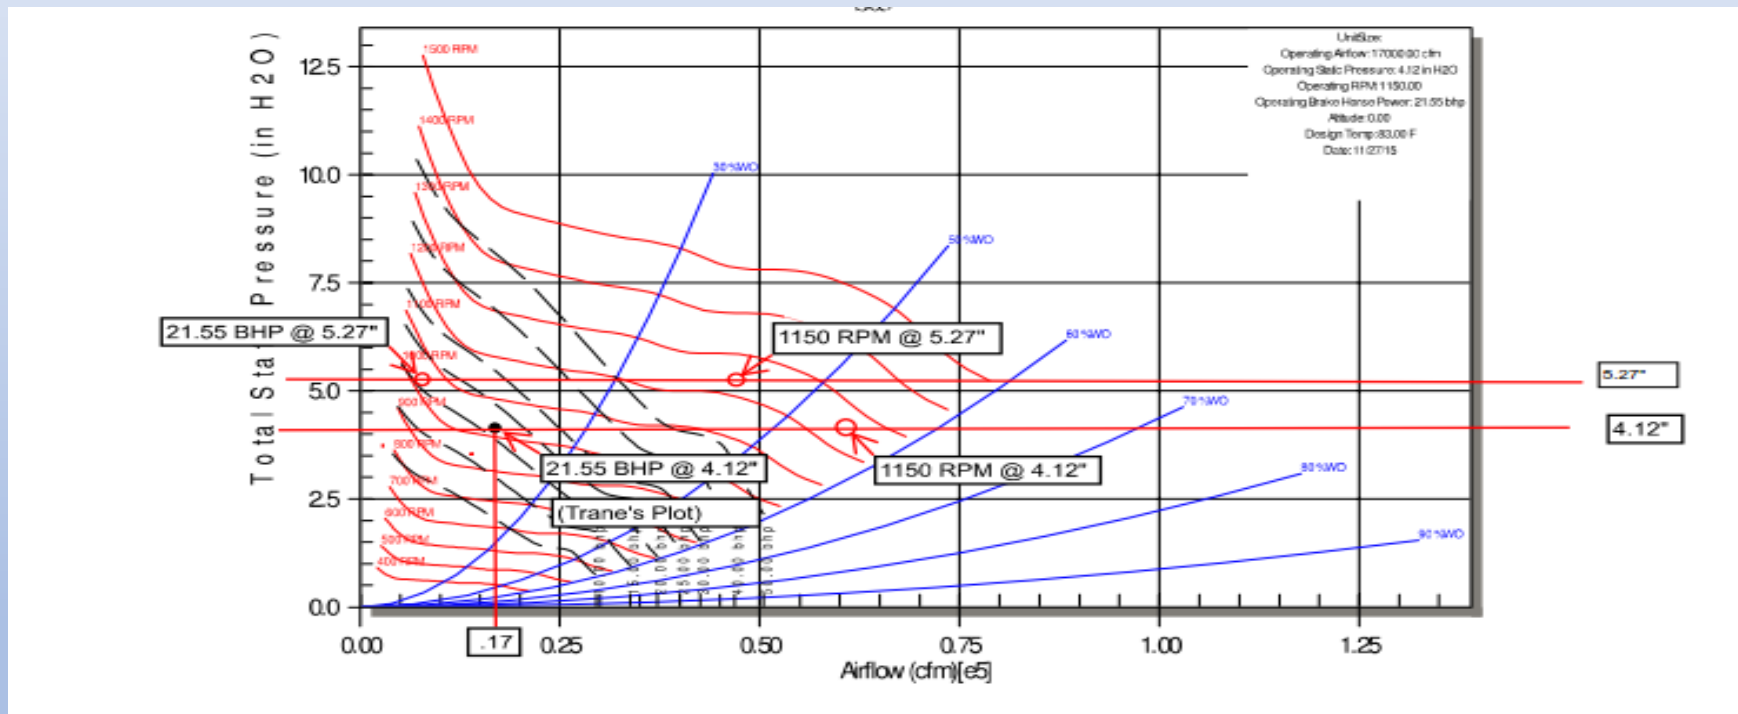
Fan Curves / Tables provide Logical Parameters, IF the correct information is given.

6,000 CFM @ 1.2" SP, 857 Fan RPM, 3.89 BHP.

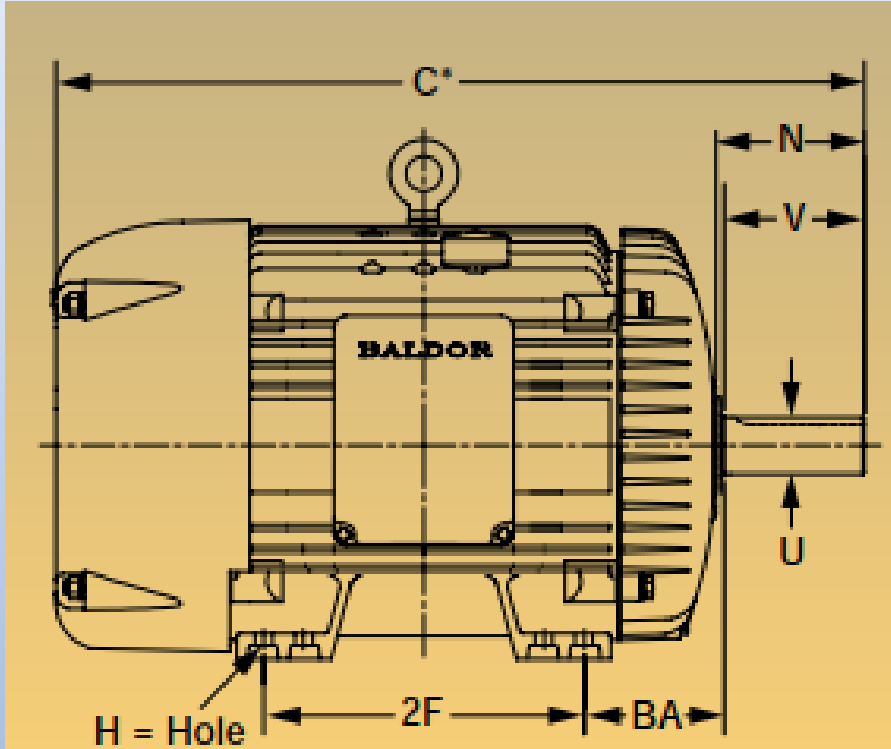
All motor frames only have ONE corresponding bore size.

This is the U- Value on The NEMA Chart

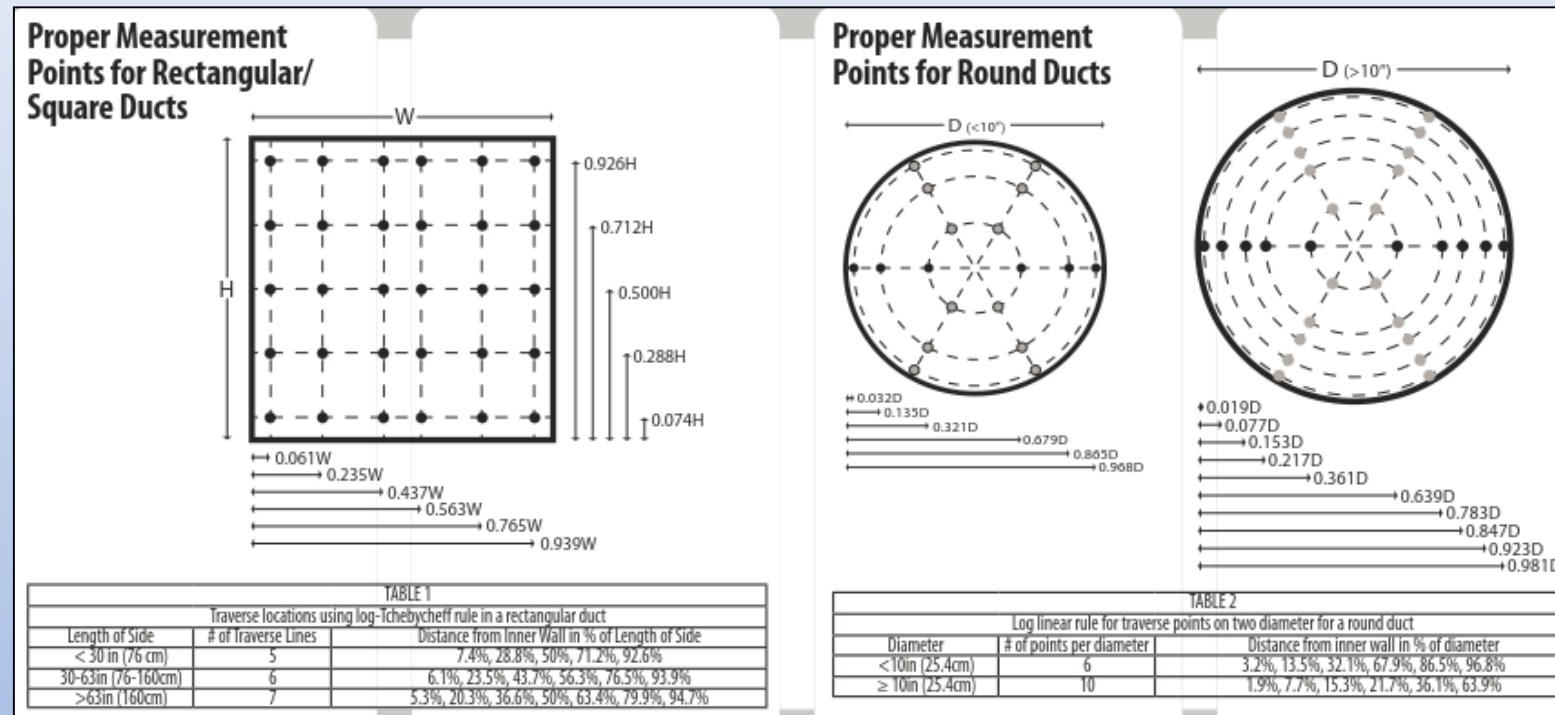
Log / Tchebycheff Duct Traverse Method

Rectangular traverse will have minimum of 25 readings, maximum of 49.
Round traverse will have a minimum of 12 readings, maximum of 20.

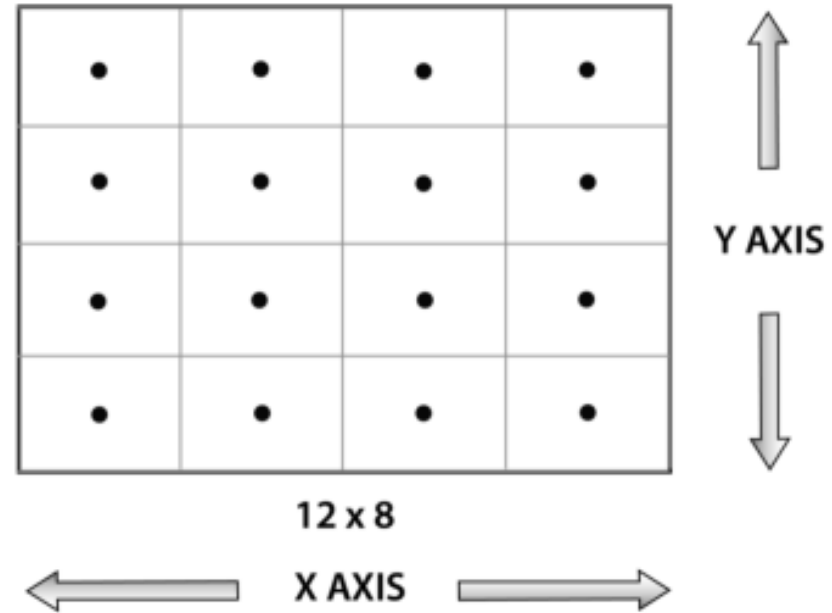
Equal Area Duct Traverse

1. Ports / markings at edges are half the distance of the rest.
2. 16 to 64 readings.
3. Ports / markings are to be no more than 6" apart.
4. Ducts larger than 48" will exceed the 6" distance to maintain 64 readings.

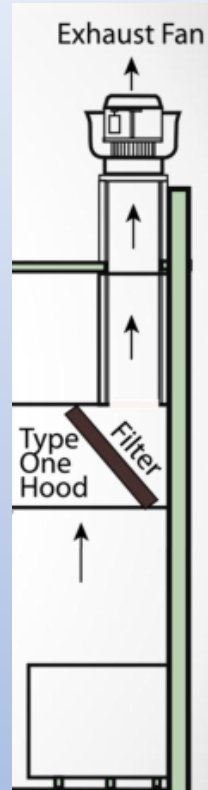
4.1 Amps
1025 Fan RPM
1.28 TESP

3050 CFM

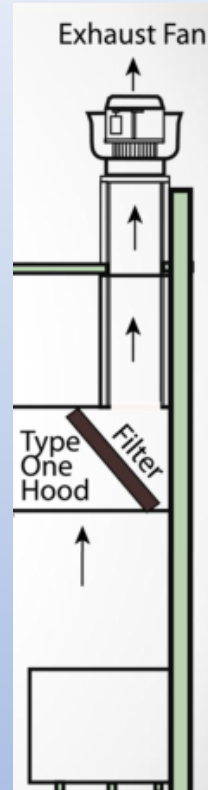
4.3 Amps
1069 Fan RPM
1.35 TESP

3125 CFM

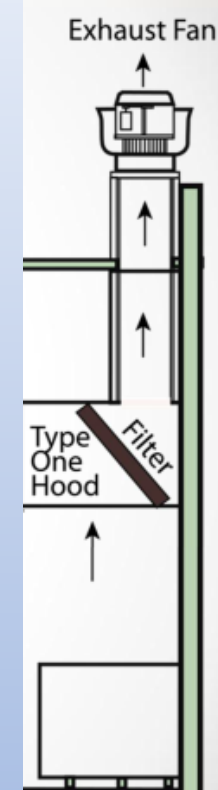
3.7 Amps
1001 Fan RPM
1.23 TESP

2980 CFM

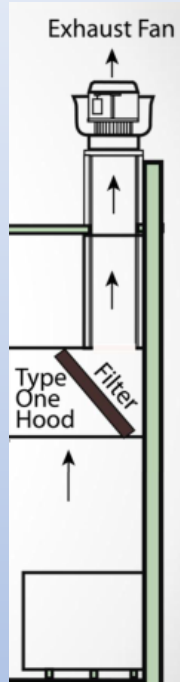
4.2 Amps
1030 Fan RPM
1.28 TESP

3890 CFM

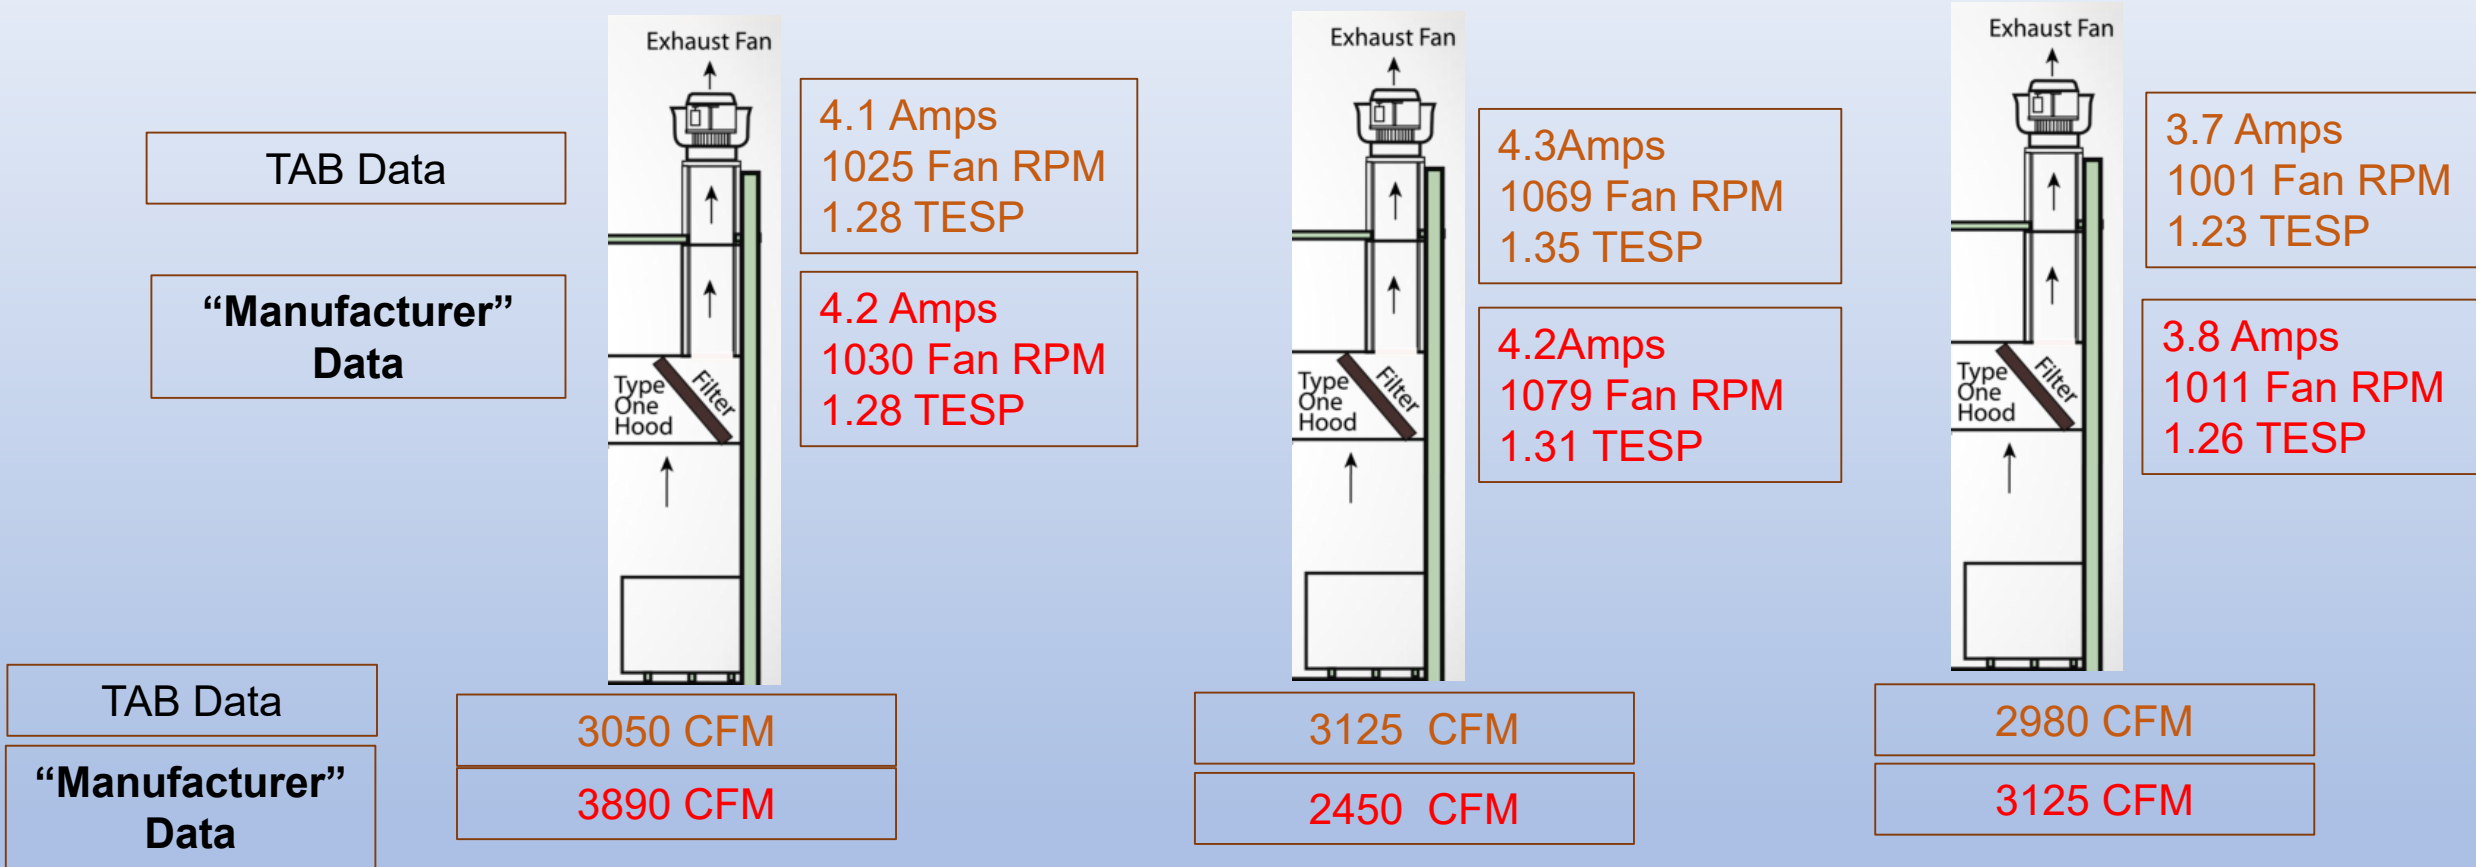
Combined Readings

What Do our Fan Laws Tell Us
About this situation?

Our FAN LAWS tell us that the airflow is the same. This is fire-rated, 16 gauge duct that was already proven to have zero leakage. Two different technicians produced almost IDENTICAL amps, fan rpms and TESP.

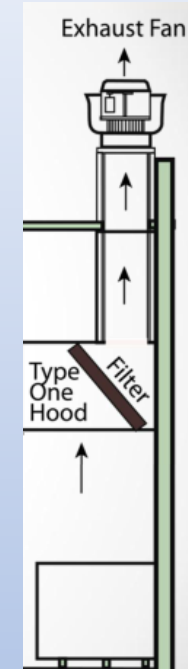
3.7 Amps
1001 Fan RPM
1.23 TESP

3.8 Amps
1011 Fan RPM
1.26 TESP
