From Estimate to Occupancy: Critical Documentation for TAB Projects

By Scott Fielder, Director, National Balancing Council

FROM ESTIMATE TO OCCUPANCY;
CRITICAL DOCUMENTATION FOR
TEST AND BALANCE PROJECTS

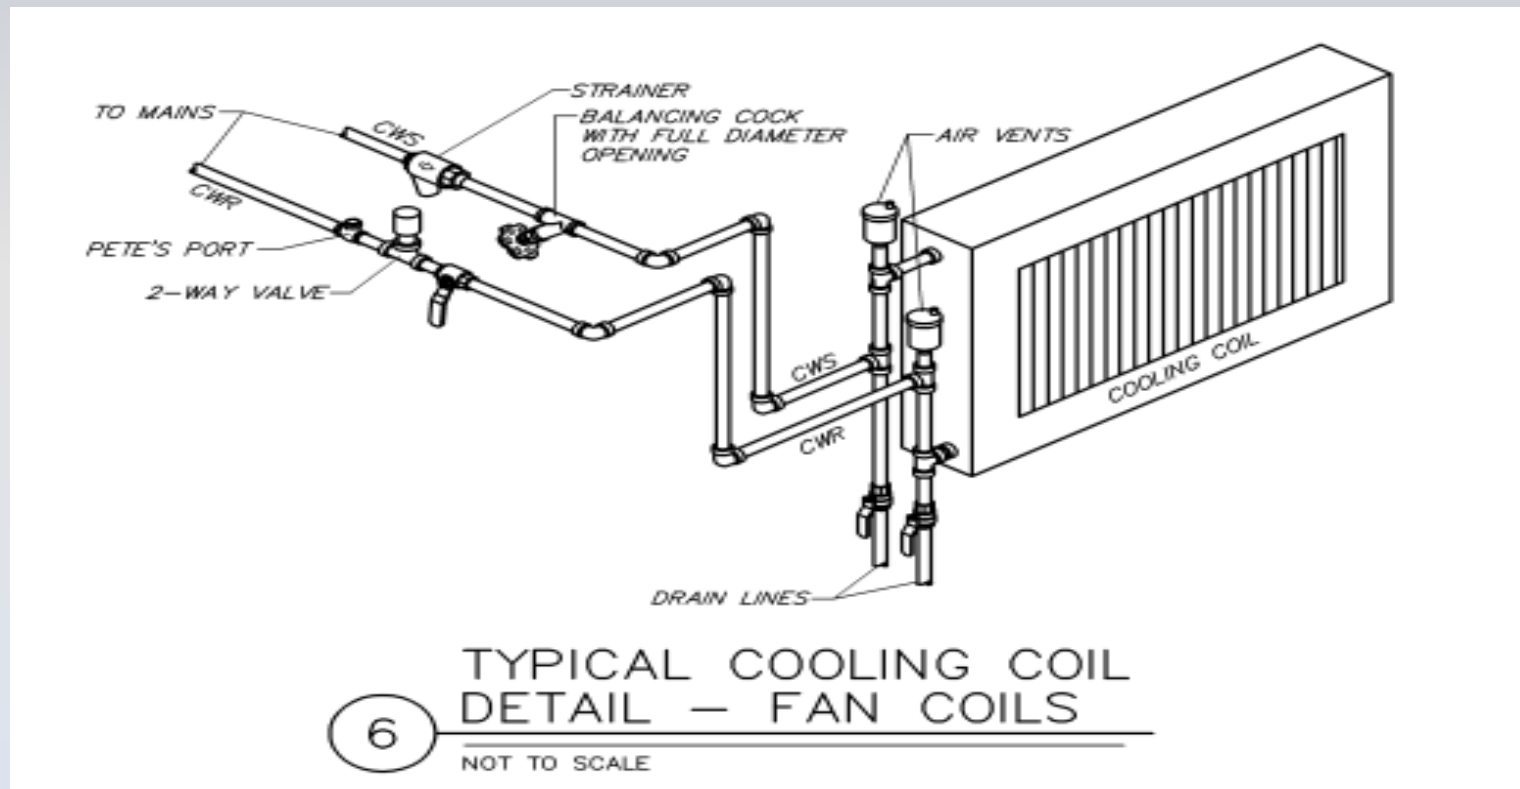
Mechanical Detail for hydronic cooling coils show no test ports or circuit setters.

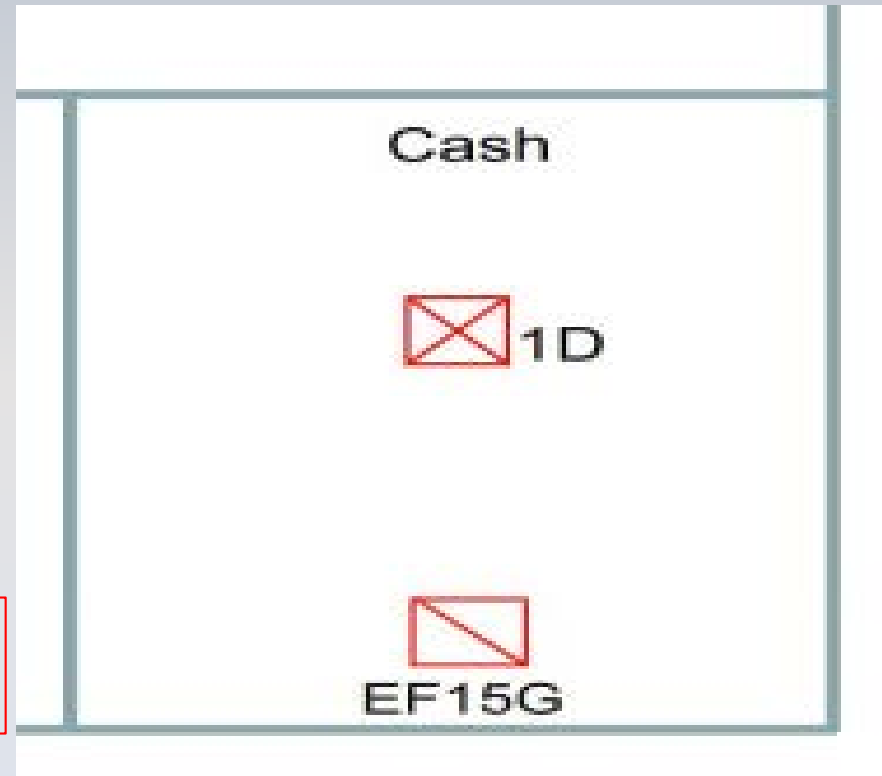
Supply Grille Register Diffuser
(Outlet)

Return / Exhaust GRD
(Inlet)

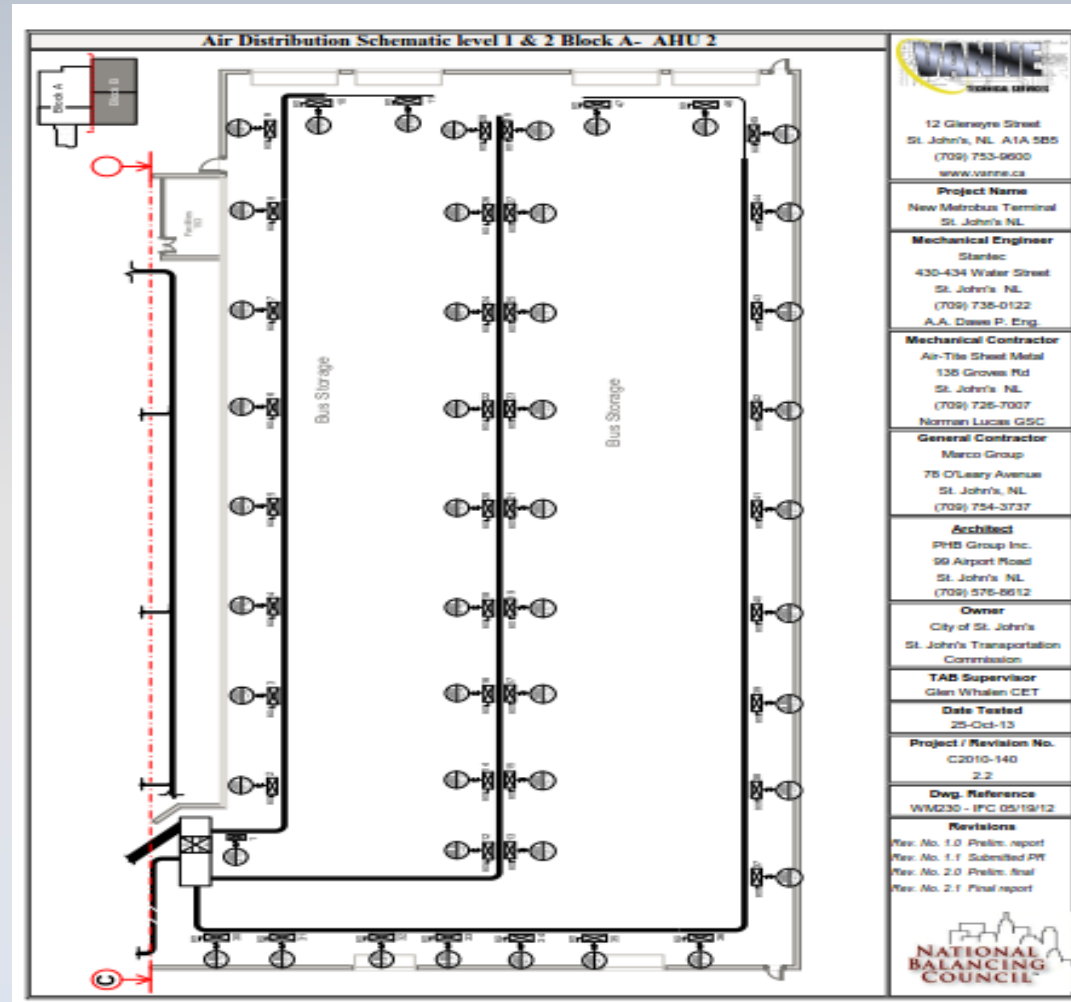
Corresponding Mechanical Drawings

Sample of Mechanical Drawings generated by the TAB Contractor.

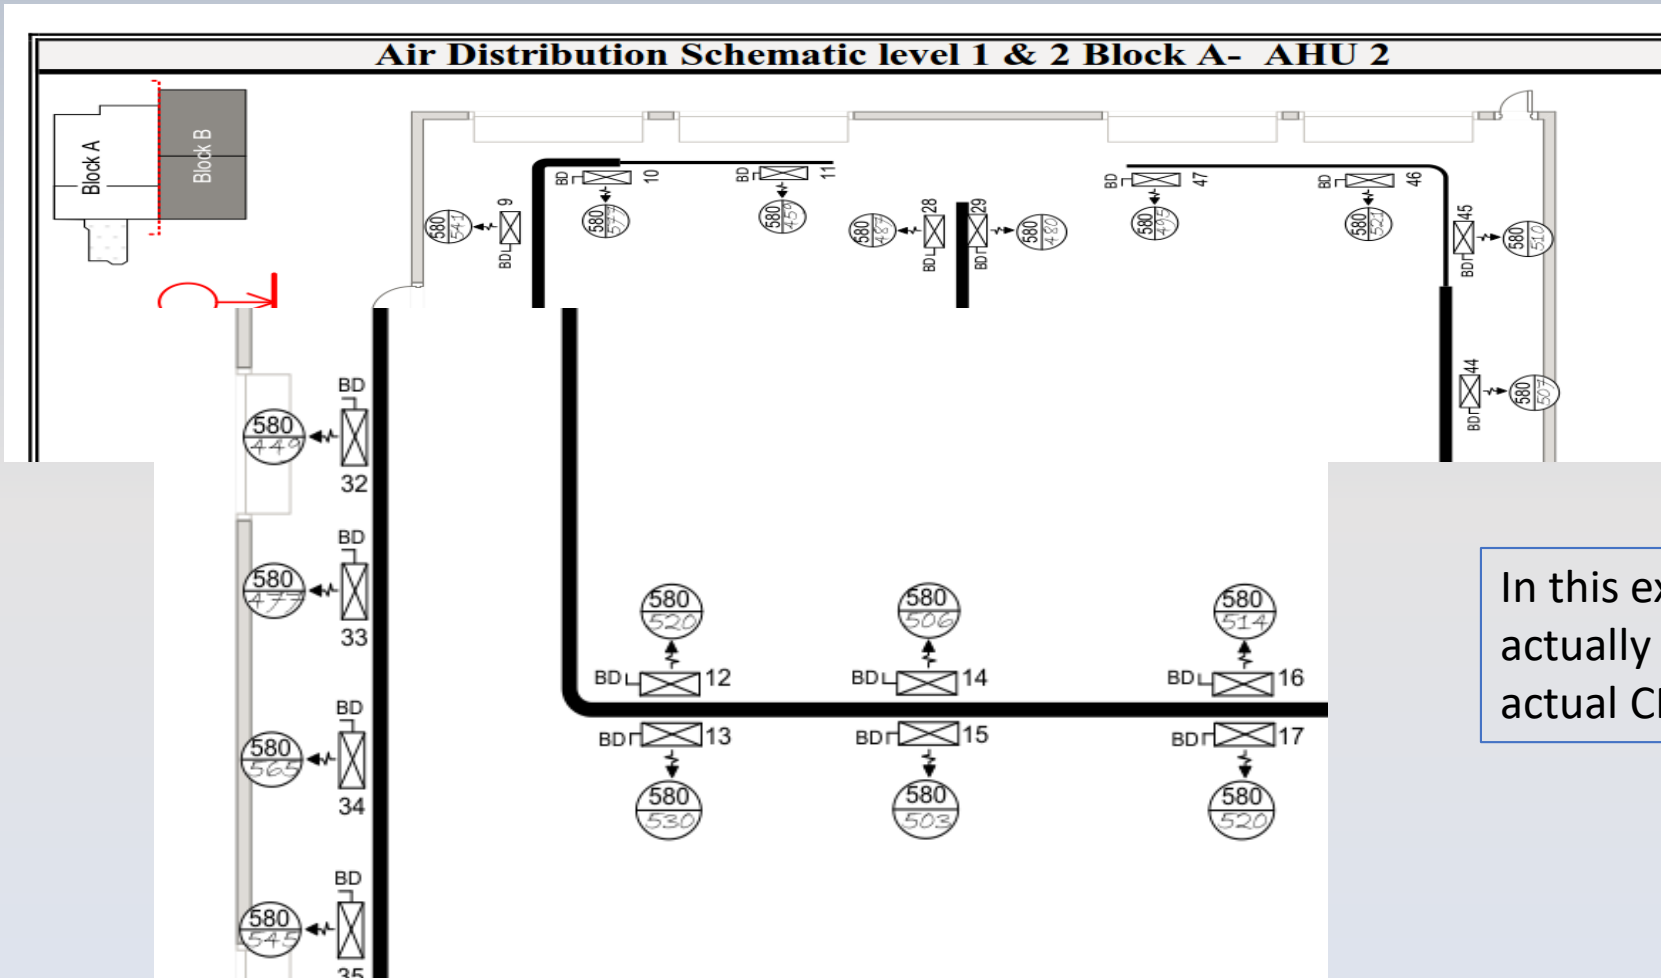
Corresponding Mechanical Drawings

In this example, the TAB contractor actually took the time to include the actual CFM by each device.

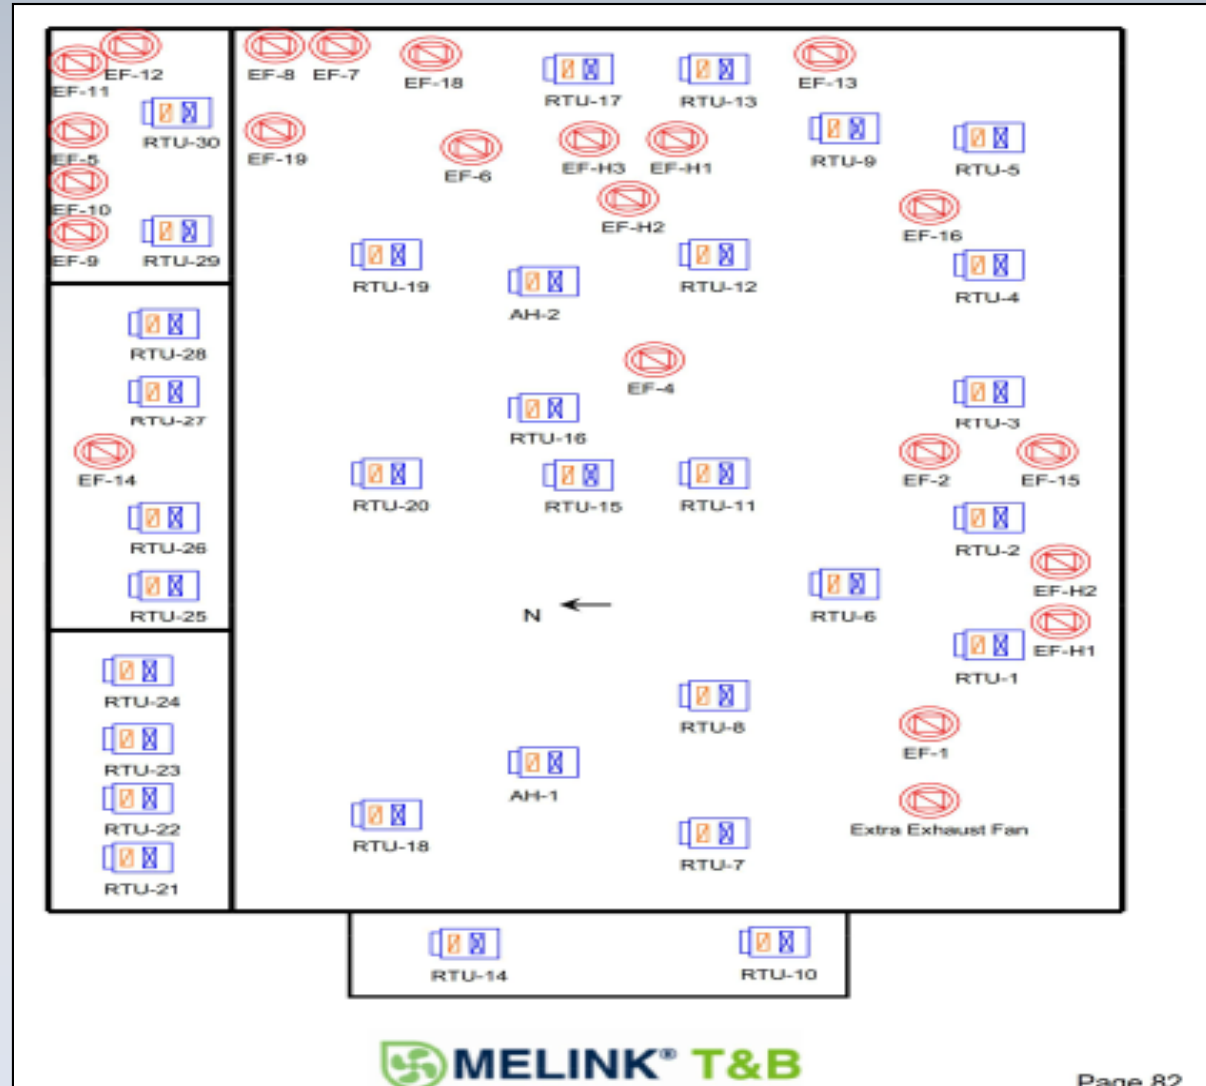
Must Include Mechanical Drawings

TAB contractor generated roof plan.
